# Analysis and Improvement of Side Mura Defect in TN mode Liquid Crystal Panel

Zhang-Xiong Jian\*, Park-Ku Hyun, Lee-Yun Bok, Che-Chun cheng, Lee-Seung Kyu  
 Product Development Institute, BOE Optoelectronics Technology Co. Ltd., Hefei 230011, China  
 Tel.:86-551-65753839, E-mail: [zhangxiongjian@boe.com.cn](mailto:zhangxiongjian@boe.com.cn).

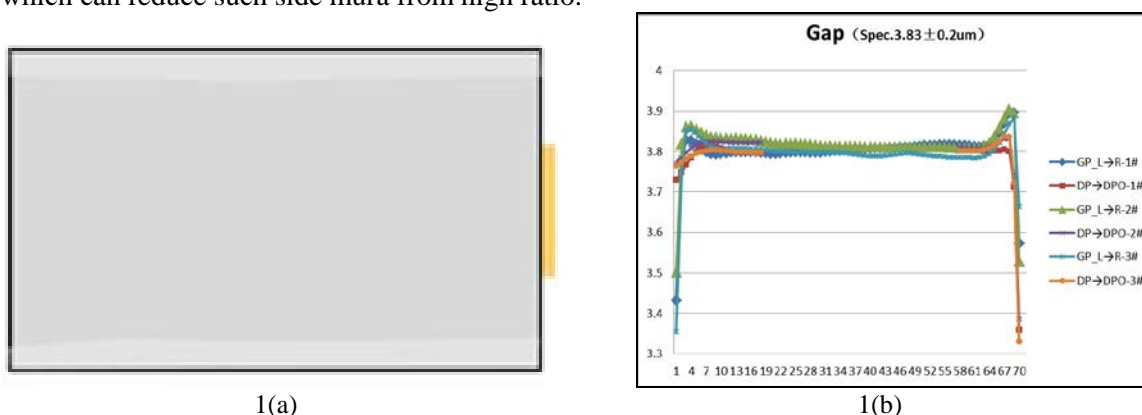
During the production of TN mode liquid crystal panels, side mura is always occurred, shown in Fig.1(a), which is harmful to improve product display quality. The reason of side mura has close relation with LCD cell process conditions, causing the shift of cell gaps in Fig1(b). By optimizing the size of silicon ball in sealant, changing the open dummy seal numbers, and researching the liquid crystal dot sizes and patterns, the side mura status is improved, the penetration of LC to sealant differently as shown in Fig3(a)(b). Those improving methods of side mura are proved to be effective by visual check. Futher more, adding dummy PS in CF mask, see Fig.3, which can reduce such side mura from high ratio.

1(a) Side Mura in black display pattern, (b) Cell Gap data of side mura area

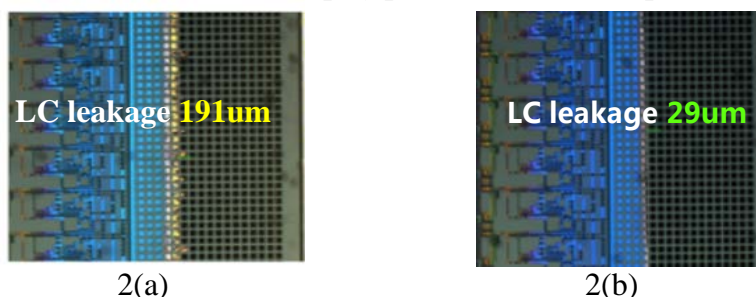
2(a) LC leakage up to 191 um in side mura defect area, (b) only 29 um in normal area
